## Repair instructions E30 heating valve

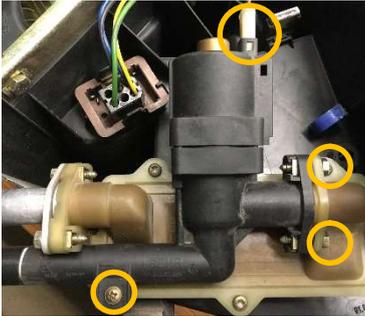
**1.** Remove the heating valve: To do this, pull the water hose off the heating valve (squeeze the hose so that no water runs out). Then unscrew the valve from the heating system heat exchanger. (3 screws) Remove the plug at the top and the valve can be removed from the heat exchanger.

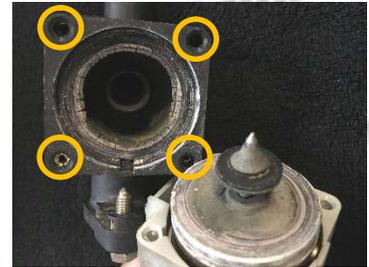
**2.** Drill out the heads of the four rivets on the upper part of the housing. (3mm drill) and slide it out downwards.

**3.** Take off the upper part of the housing including the coil and remove the old seal. Check the coil for corrosion. Replace if necessary.

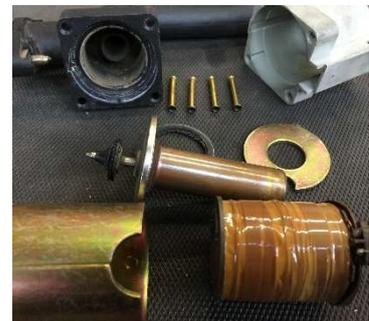
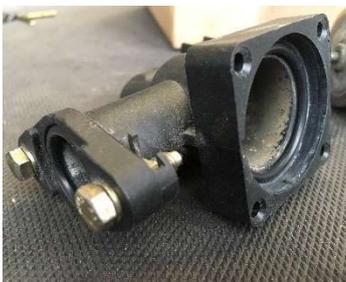
**4.** Clean the sealing surface for the large seal and insert the new seal.

**5.** Carefully screw both housing parts together with the screws and nuts provided.

Danger! First tighten all four screws slightly and then tighten them one after the other. Do not overtighten, otherwise there is a risk of damaging the housing. **6.** Dichtfläche für kleinen O-Ring reinigen und neuen O-Ring einlegen.
